Tips & Technology

Current topics for successful workshops No. 11/2015

Tips for Diagnostics and Repair

Experience-based repair

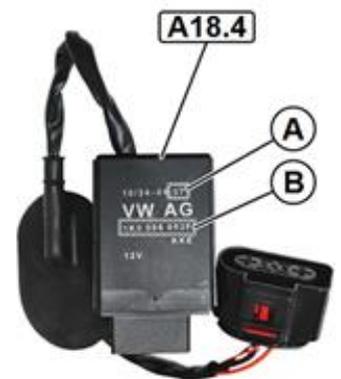
Complaints:

- The engine turns off while driving.
- The engine does not start.

- Possible fault memory entry in the engine control unit.
 - P3043 electric fuel pump - mechanical error
- The component A18.4 is used in the following design:
 - Control device software number (A): 06
 - Part number (B): 1K0 906 093 F
- Or:
 - Control device software number (A): 06
 - Part number (B): 1T0 906 093 F
- The electric fuel pump and associated cables are technically in proper condition.
- The electric fuel pump is integrated in the fuel tank installation unit.

- The complaint stems from a software-related malfunction of the electric fuel pump control device.

- Check the electric fuel pump control device and replace if necessary.
- Replace the electric fuel pump control device with a version having the same part number, but the control device software number should be 07.
